Re: Request for Certification of Emergency:

Sconset Bluff - Baxter Road

# BAXTER ROAD TEMPORARY STABILIZATION NOI SUBMISSION

# BAXTER ROAD TEMPORARY STABILIZATION PROJECT NOTICE OF INTENT (DEP FILE NO. SE 048-2610)

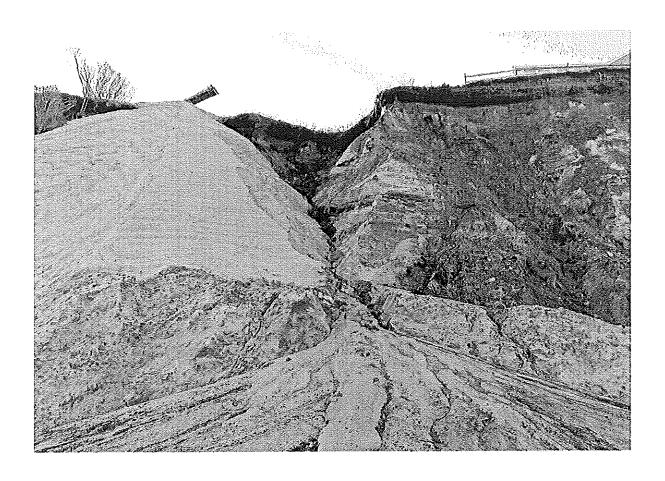
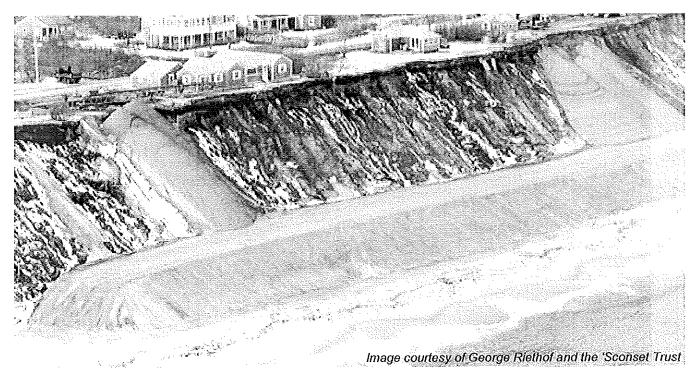
Baxter Road Geotube Project Nantucket, MA

The upper portion of 'Sconset bluff (above the geotube installation at 87-105 Baxter Road) exhibits evidence of rill erosion from rainfall and stormwater runoff from the top of the coastal bank. The attached Photographs 1-4 show the development of rivulets and small gullies in the bank face. While the geotubes have served to protect the toe of the coastal bank from waves and storm surges, erosion of the upper bank due to runoff over the bank surface and slumping due to gravity mass failure will likely continue unless additional measures are undertaken to protect this bank area. See attached memo from Mark Haley dated March 12, 2014, on the need for vegetation of the bank face.

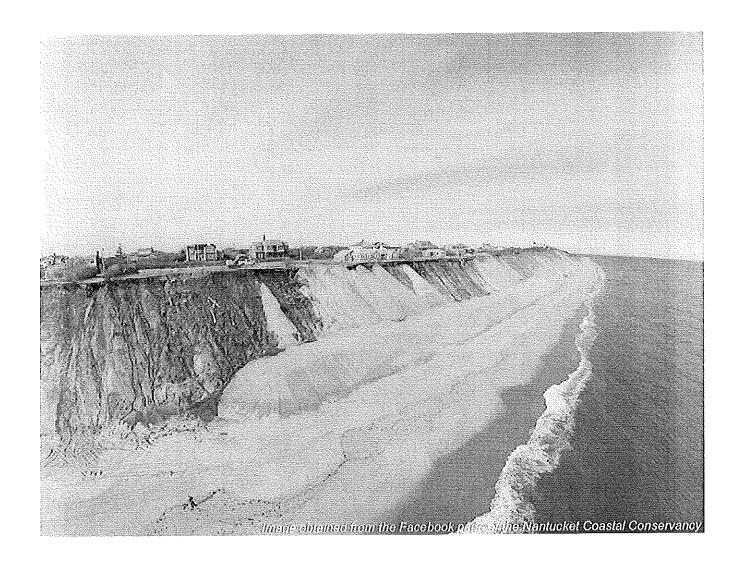
During the construction process, additional sand was placed at or near the sand delivery locations at 87/91 and 99/101 Baxter Road (see attached Photograph 5). It has been observed that this sand acted to protect the face of the bluff because it increased infiltration of rain and surface water runoff and also attenuated soil erosion from rain and surface water flows. In the areas where the face of the bluff was not augmented with additional sand, surface water flows continued to erode that portion of the bluff above the geotubes.
